**TRANSACTIONS  
OF THE INSTITUTE OF  
FLUID-FLOW MACHINERY**

## On the effectiveness of fixing cavitation damages with new electrodes featured by a metastable structure of the padding weld

A family of new experimental electrodes with metastable structure of the padding weld have been developed for fixing material damages caused by cavitation impingement in hydraulic machines and devices. High effectiveness of cavitation erosion repair as well as good welding features are found to be rudimentary features of the manufactured electrodes. In the paper the results of laboratory and field tests of the coatings created by means of the new electrodes are presented.

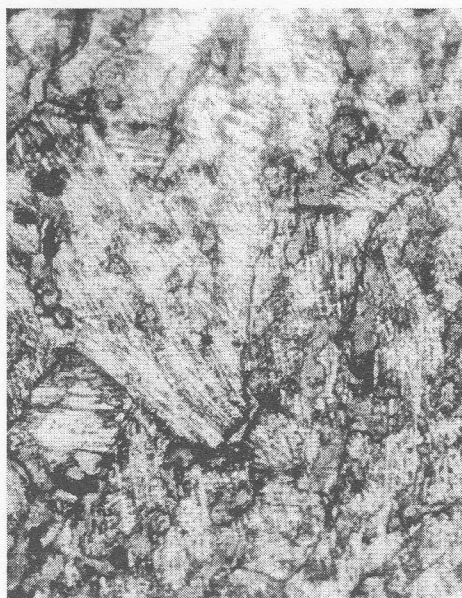
The metallographs of the padding structure created by means of the IMP6 electrode are shown in Fig. 1. The sample was not subjected to cavitation erosion in this case. In Fig. 1a the structure of the pad at the sample surface is shown. The martensitic needles, parallel within the grains, accompanied by a large amount of retained austenite are easily visible. Local extrusions of chromium carbides are overspread. The same structure is found 0.5 mm beneath the specimen surface

Fig. 1a. The structure of the pad created by means of the IMP 6 electrode – the surface layer of a not cavitated sample. Magnification 280x.

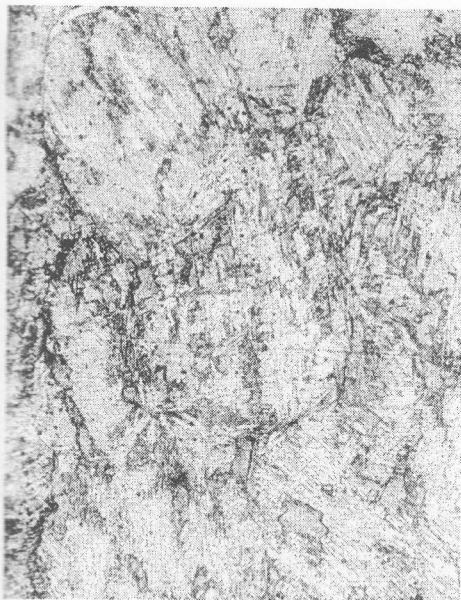
Fig. 2c. The structure of the pad created by means of the IMP 6 electrode – 1.5 mm beneath the cavitated specimen surface. Magnification 400x.

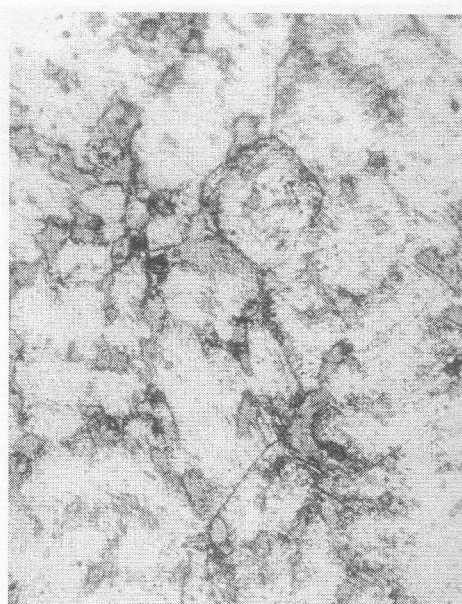
Fig. 3b. The structure of the pad created by means of the EN10-10B electrode – 0.5 mm beneath the cavitated specimen surface. Magnification 280x.

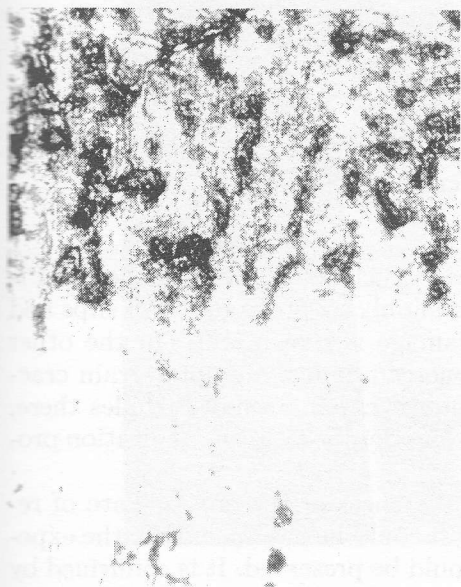
Fig. 4c. The structure of the pad (made by the IMP 1 electrode) and the core material (2H13) beneath the in-melt line. Magnification 280x.

(Fig. 1b). The grains of dendritic shape are elongated towards the maximum heat removal direction. They meet their end at the in-melt line of the pad into the core material (Fig. 1c). A layer of the core material lying directly under that line is also transformed to martensite with a large amount of carbides localized mainly along the grain boundaries. At the depth of 2.3 mm stripped martensite is cut with the strips of carbide extrusions along the grain boundaries (Fig. 1d). The image of an unaltered structure of the core, 2H13, material is presented in Fig. 1e. The development of cracks on the surface of cavitated sample with a pad produced by means of IMP6 electrode is presented in Figs 2a and 2b. A fine martensitic structure with retained austenite was achieved in the surface layer of the material (Fig. 2c). The similar structure was identified in the surface layer of the sample coated with an EN10-10B electrode (Fig. 3a and 3b). Beneath the in-melt line the assemblies of carbides are visible in the background of martensite (Fig. 3c and 3d). Boundaries of prior austenite are also visible. Somewhat different structure is shown on the layer deposited with the IMP1 electrode. It is presented in Fig. 4a, 4b, 4c and 4d for various depths inside the sample. Almost pure martensite is revealed within the melted zone (Fig. 4a and 4b). Under the in-melt line it changes into martensite with carbides partitioned by the boundaries of prior austenite (Fig. 4c and 4d).
